# ASSESSMENT OF DAM SAFETY OF COAL COMBUSTION SURFACE IMPOUNDMENTS

**Gulf Power  
Plant Scholz  
Sneads, Florida**

Prepared for  
*U.S. Environmental  
Protection Agency  
Washington, D.C.*

October 2012

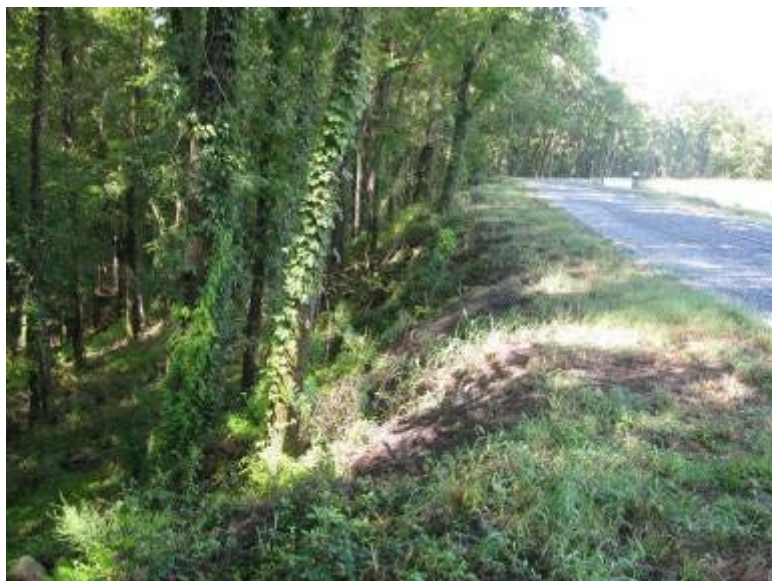
Photo 5: Lower Pond – Southeast embankment exterior slope, looking southwest. Note steepness, eroded areas along crest, trees, and dense vegetation.

Erosion rills and scarps – Erosion rills and scarps were observed on the exterior slopes of the south and southeast embankments of the Lower Pond. Place and compact structural fill in the rills and scarps and grade to adjacent existing contours. Trees and dense vegetation should be removed and embankments slopes be restored to the original contours by placing select structural fill in 12-inch lifts and compacting as recommended by a professional engineer.

After slope restoration, it is recommended to stabilize the exposed surface of the embankment with sod, hydro seeding, or riprap consisting of a heterogeneous mixture of irregular-shaped rocks placed over the compacted fill and a geotextile fabric.

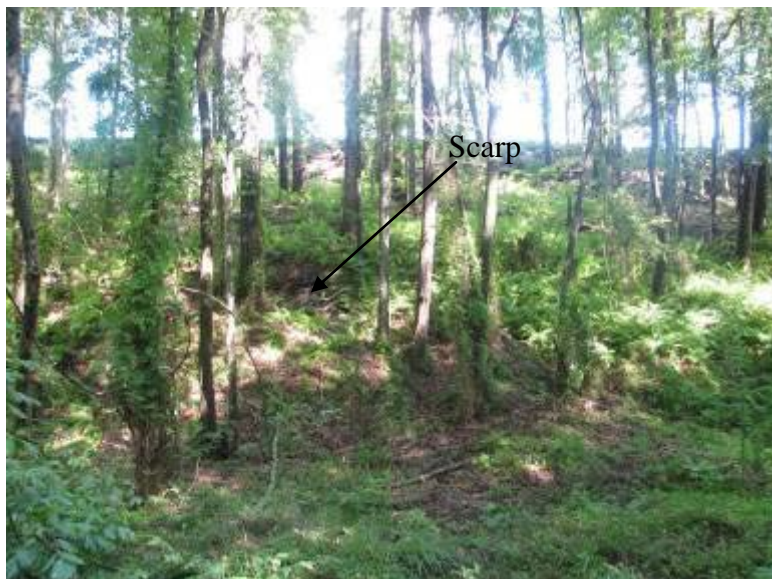
Photo 17: Lower Pond – Southeast embankment exterior slope, looking north from toe. Note scarps, steepness, trees, and dense vegetation.

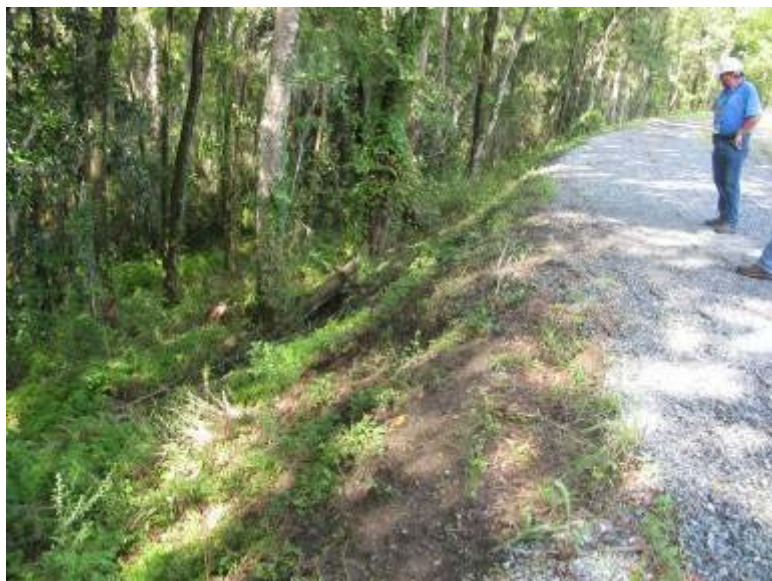
Photo 19: Lower Pond – Southeast embankment exterior slope, looking southwest. Note trees, dense vegetation, and erosion along crest.

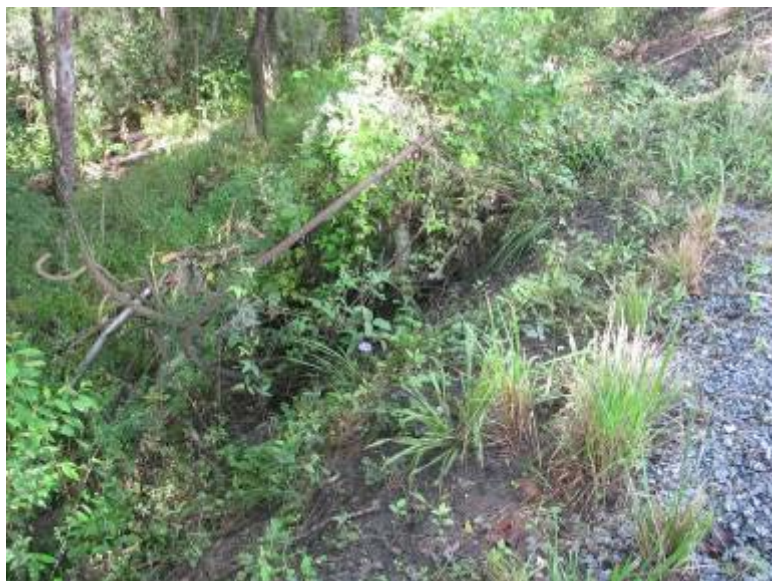
Photo 21: Lower Pond – South embankment exterior slope, Miscellaneous trash and debris.

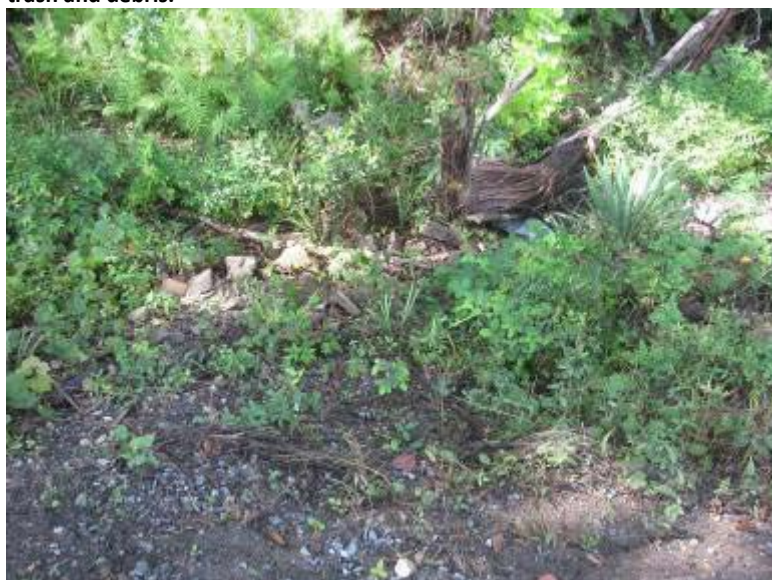
Photo 23: Lower Pond – South embankment exterior slope, Miscellaneous trash and debris looking west.

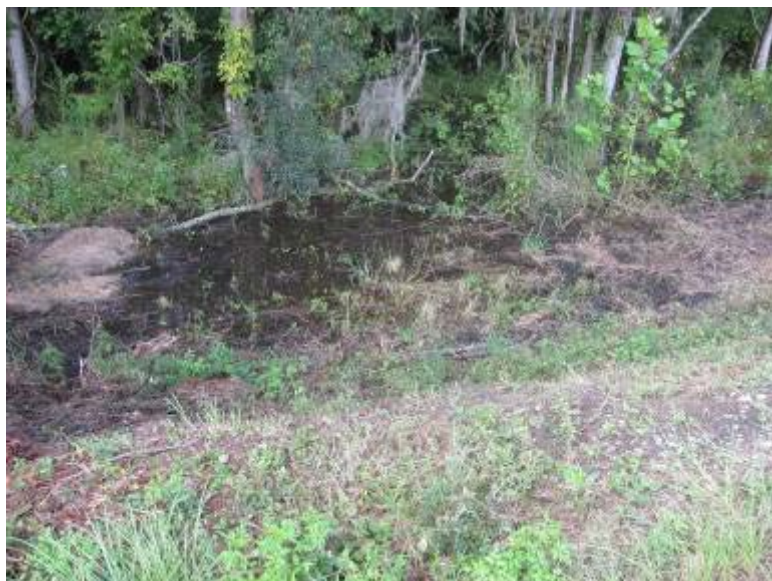
Photo 25: Lower Pond – Southwest embankment toe of exterior slope, Area of standing/ponded water looking west.

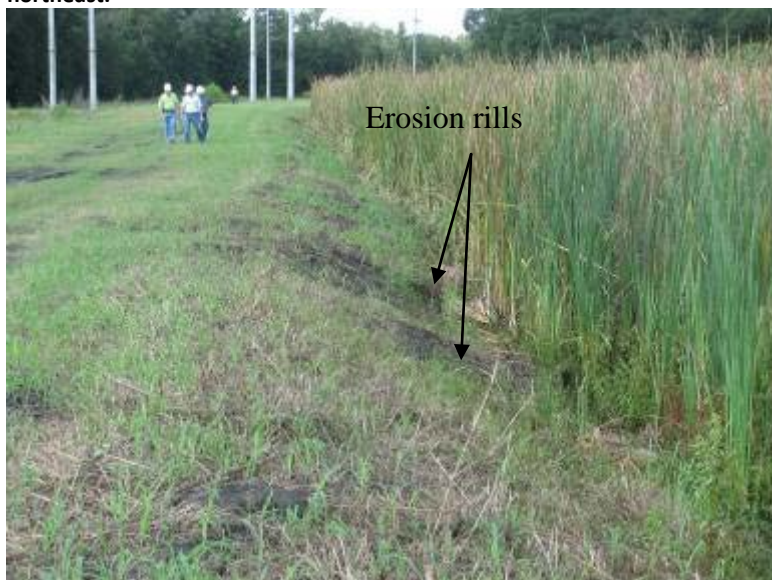
Photo 31: Middle pond – Divider embankment interior slope looking southwest. Note erosion rills on slope.

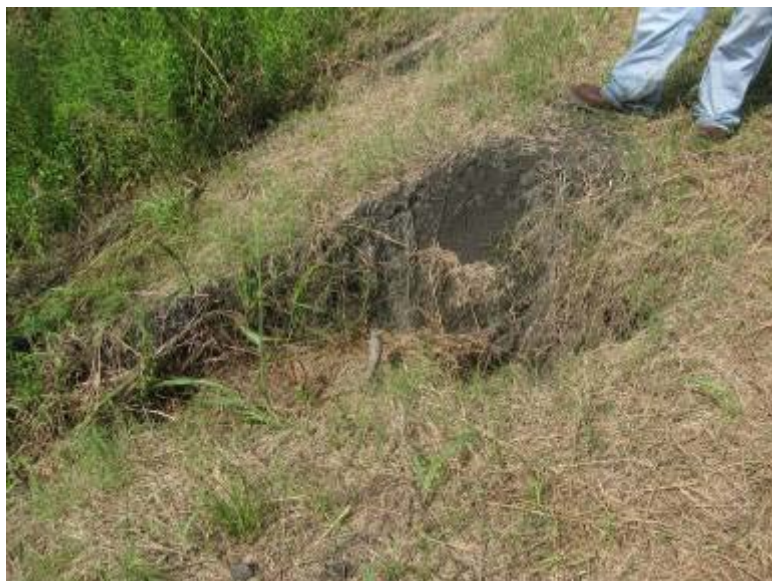
Photo 37: Middle Pond – North embankment interior slope, erosion rill looking west.

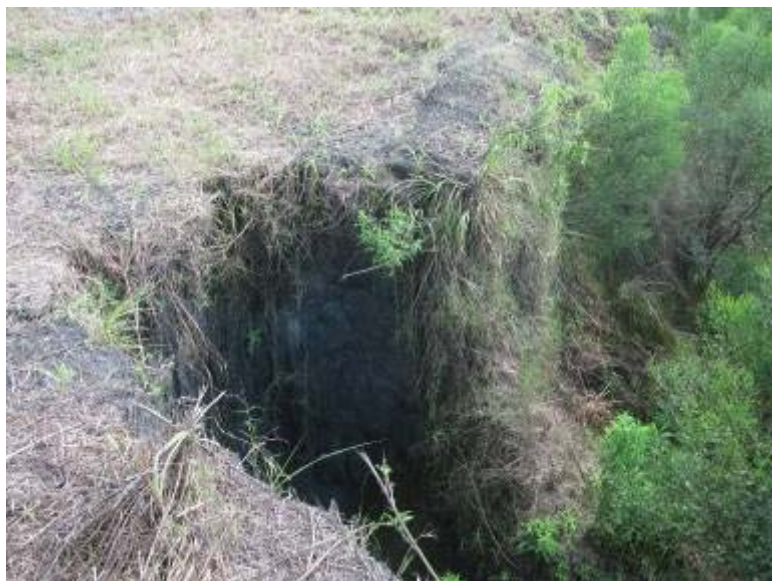
Photo 41: Middle Pond – North embankment interior slope, scarp looking east.

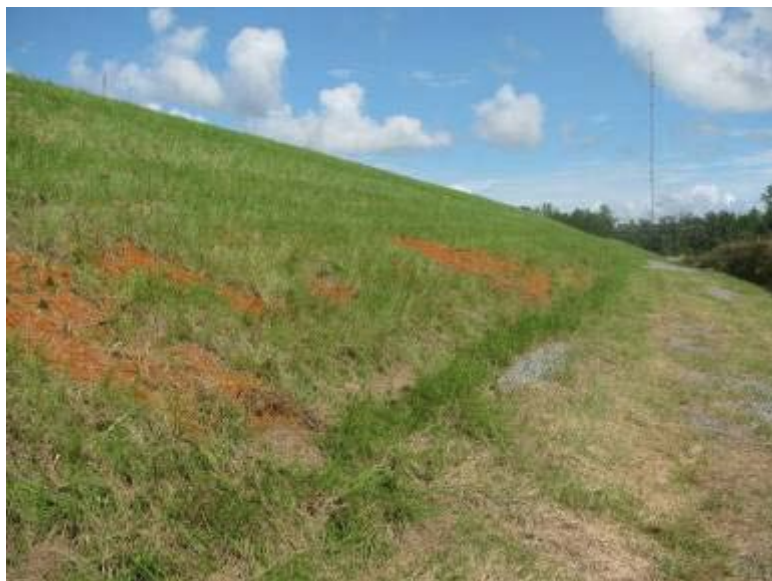
Photo 45: Upper East Pond – East embankment exterior toe of slope looking north. Note recently repaired/backfilled areas where prior erosion had occurred.

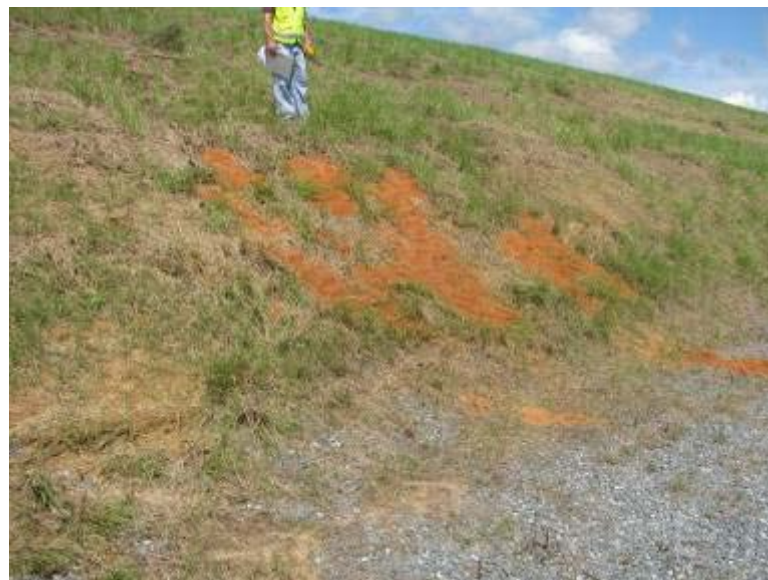
Photo 48: Upper East Pond – East embankment exterior slope looking north. Note recent repair of erosion rills.

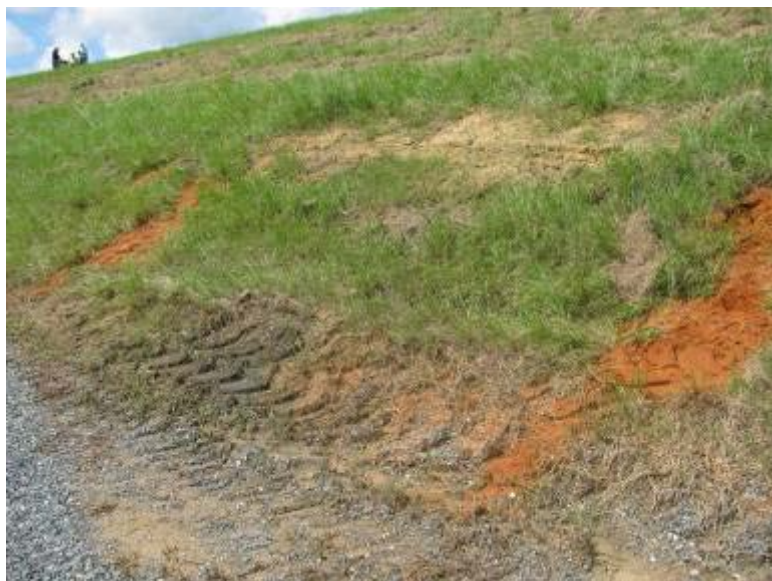
Photo 49: Upper East Pond – East embankment exterior slope looking west. Note saturated area at toe of slope.

Monitoring for potential seepage at the toe of slope of the east embankment, where saturated areas were observed, is recommended.

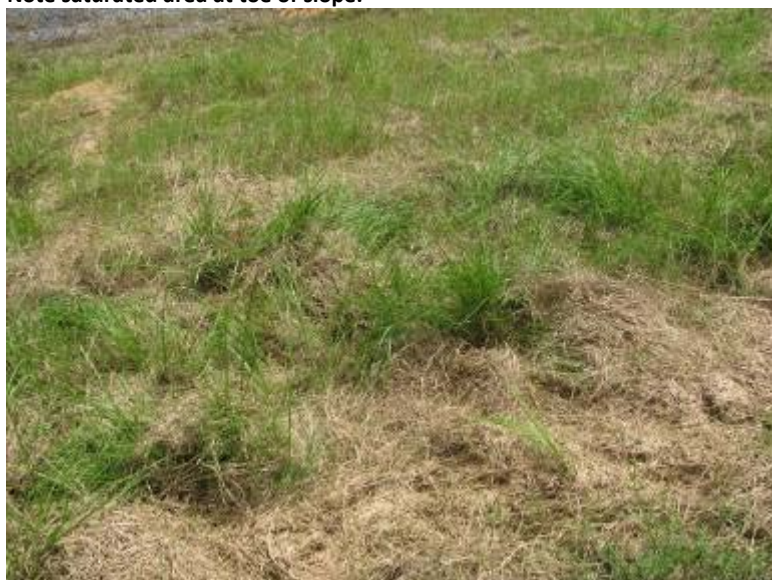
Photo 51: Upper East Pond – East embankment exterior toe of slope, looking west. Note area of possible seepage and depression 3-foot wide by 10-foot long by 6-inches deep.

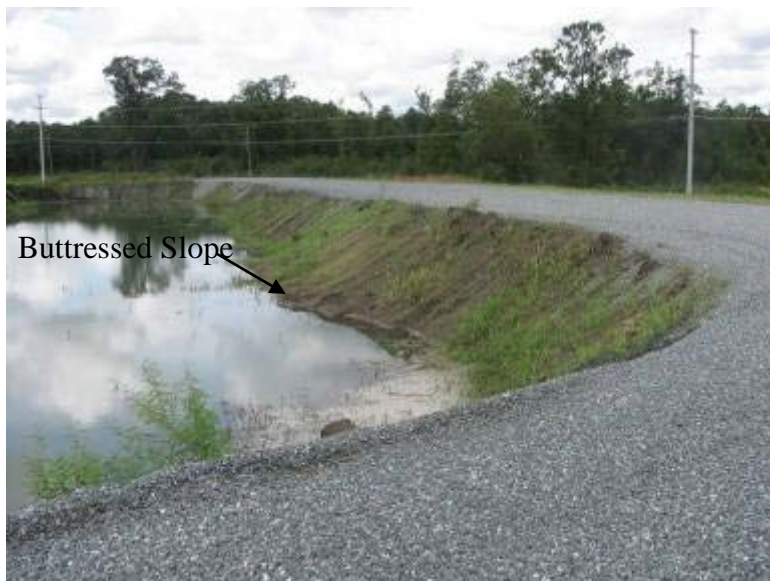
Photo 53: Upper East Pond – North embankment interior slope looking west. Note buttressed slope from previous repairs.

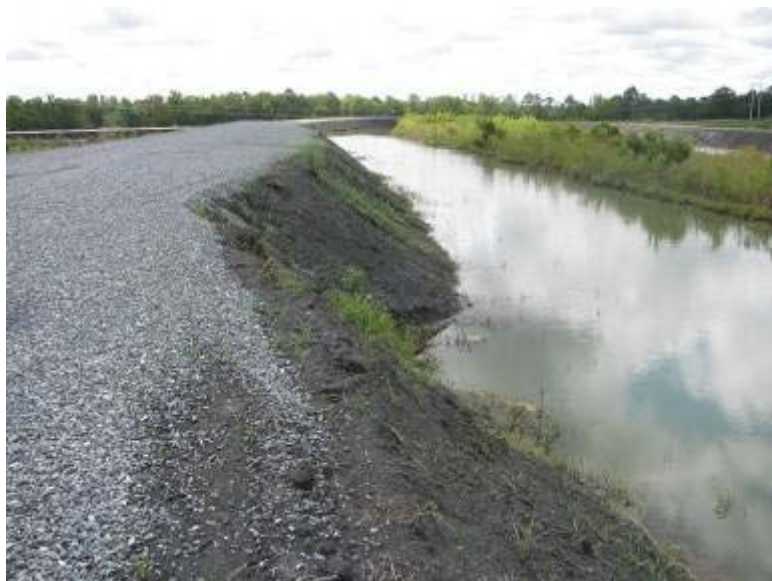
Photo 57: Upper East Pond, Divider embankment interior slope looking south at embankment erosion.

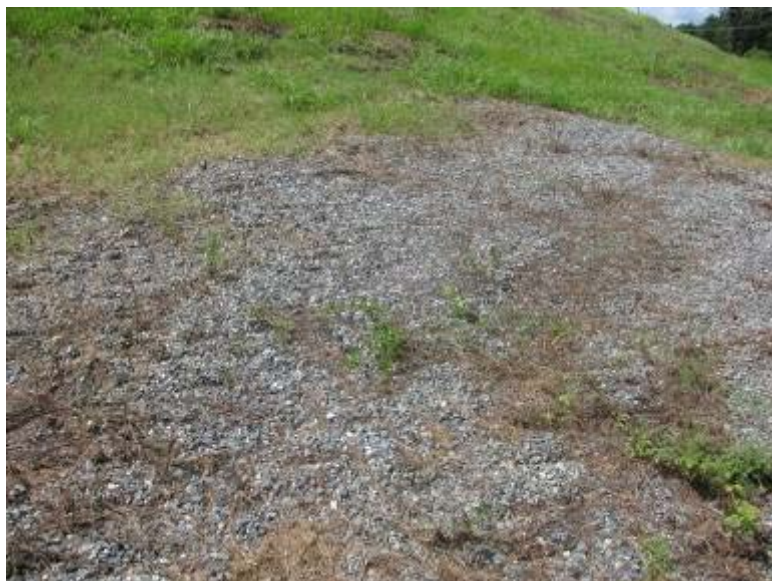
On October 2, 2010 during routine observations near the toe of slope of the north embankment of the Ash Pond (Upper East Pond), seepage was observed. A disturbance in the surface water of the pond indicated the location of the seepage area. The plant personnel immediately utilized on-site equipment to place ash on the interior slope, which reportedly stopped the seepage. After visual inspection by Southern Company Services (SCS), the recommended final repair was to install a reverse filter consisting of sand overlain by #89 and #57 Stone in the area where the seepage emerged on the toe of the exterior slope. SCS performed subsequent seepage modeling to evaluate the benefits of adding a toe berm at the toe of slope of the north embankment. However, based on the results obtained with the analysis, SCS concluded that a toe berm would provide little or no benefit, and the cost of such remedial work was unnecessary.

Photo 61: Upper East Pond – North embankment exterior slope, repair of seepage area.

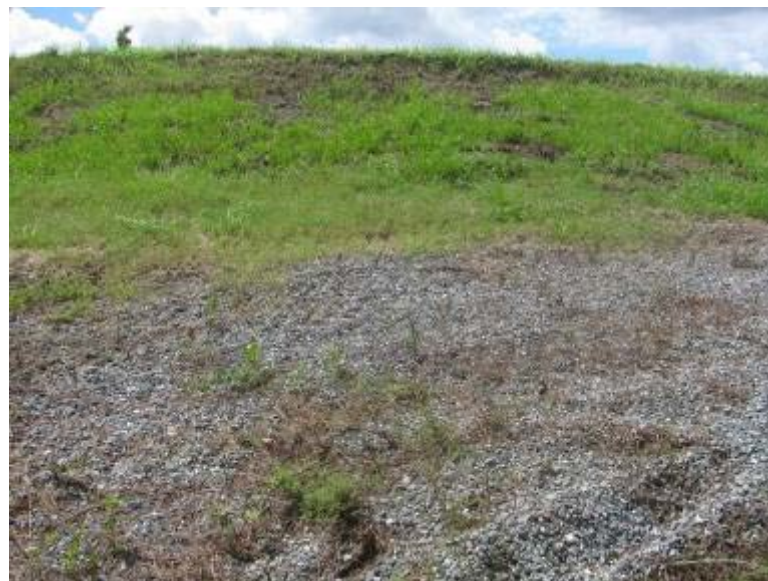
Photo 62: Upper East Pond – North embankment exterior slope, Repaired area where seepage from pond had previously occurred at toe of slope.

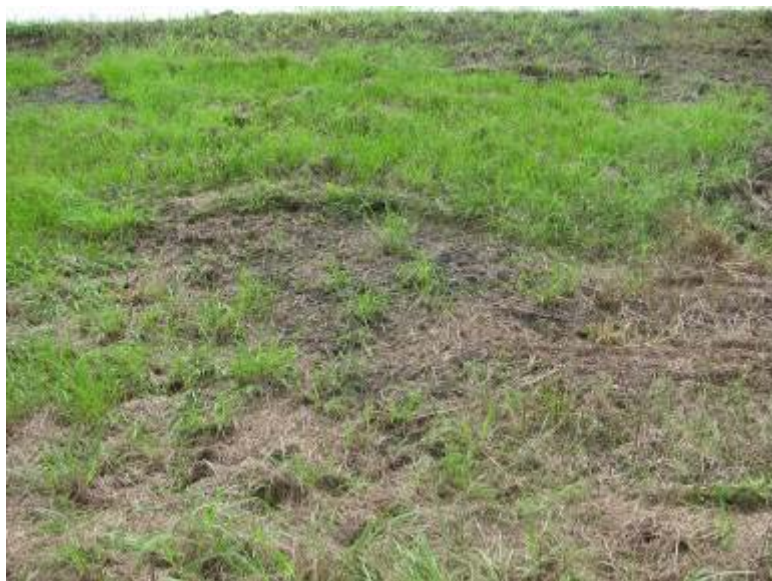
Photo 63: Upper East Pond –North embankment toe of exterior slope looking south. Note saturation at toe of slope.

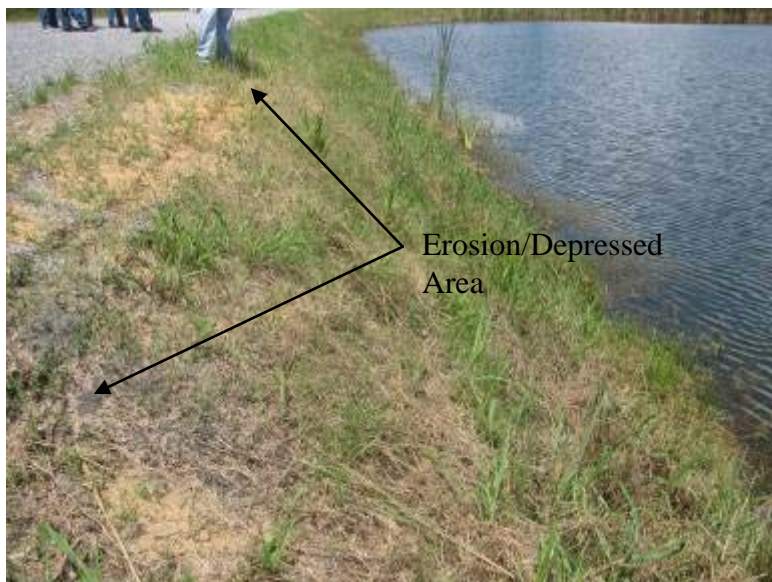
Photo 73: Upper West Pond – West embankment interior slope, showing erosion/depressed area approximately 30-foot long, looking north.

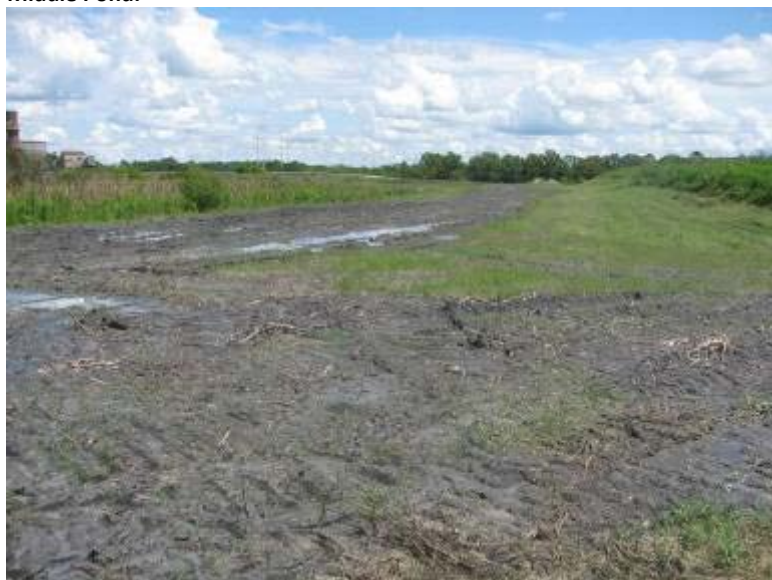
Photo 79: Crest of divider embankment between Middle Pond and Upper West Pond, looking southeast at excavator tracks.

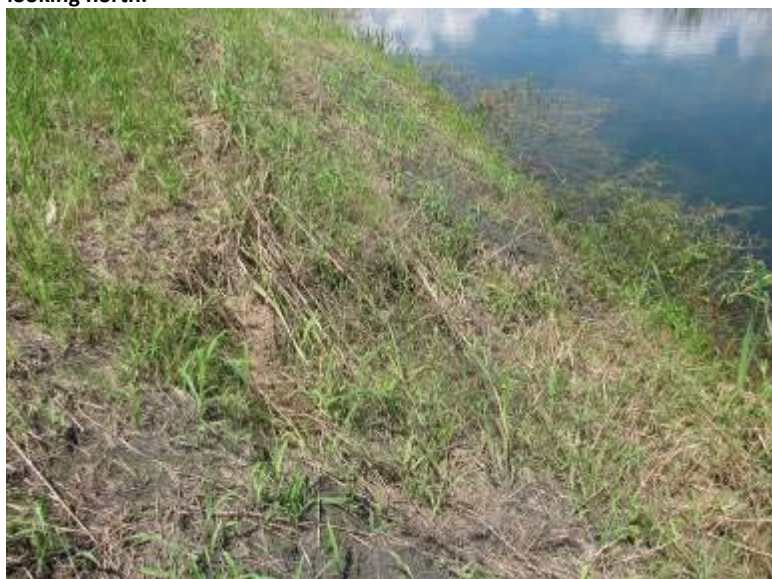
Photo 87: Upper Middle Pond – Divider embankment interior slope scarp looking northwest.

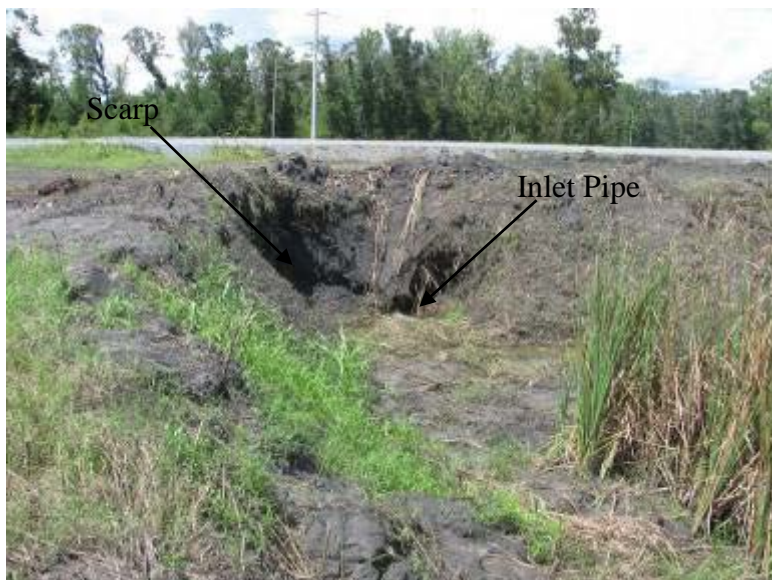
Photo 89: Upper Middle Pond – Divider embankment interior slope, 18-inch diameter corrugated HDPE inlet pipe, looking north. Note scarp adjacent to pipe.

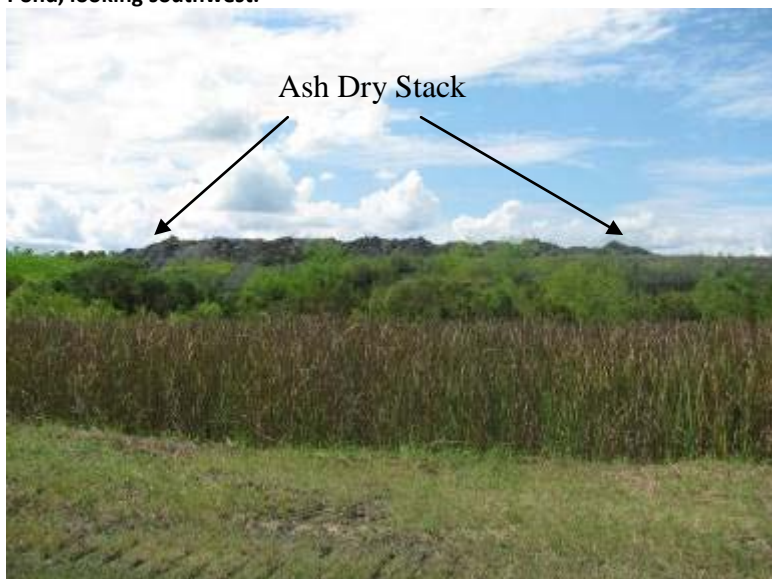
Photo 111: Middle Pond - Southside of Ash Dry stack area, looking northwest. Slope along South side of Ash Dry Stack area is nearly vertical and inaccessible.
